NATIONAL TRANSPORTATION SAFETY BOARD

SAFETY STUDY

Emergency Evacuation of Commercial Airplanes

**NTSB/SS-00/01
PB2000-917002
Notation 7266
Adopted June 27, 2000**

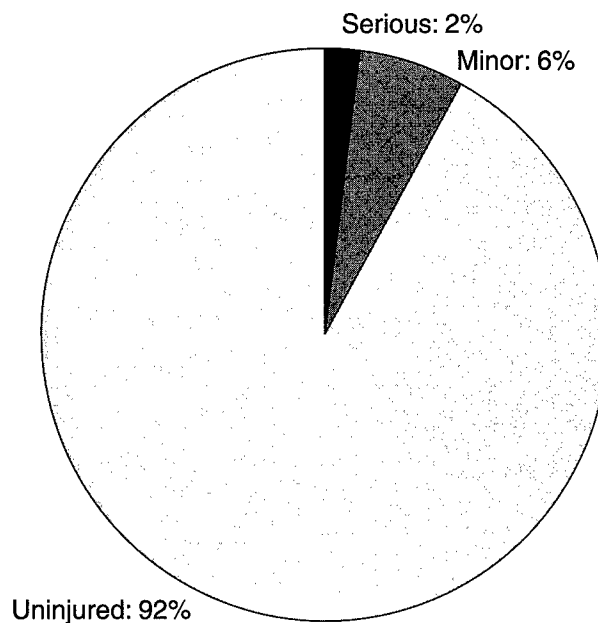
Figure 3-1. Percent of crew and passengers who sustained serious or minor injuries in the 46 study cases.

In the 46 study cases, 2,651 passengers and 195 crewmembers evacuated from planes. There were no accident- or evacuation-related injuries in 28 of the cases (table 3–4). Accident- or evacuation-related injuries occurred in 18 of the cases; 208 passengers and 13 crewmembers were injured, and 10 passengers and 1 crewmember were killed (table 3–5). One of the cases (case 45, in Little Rock, Arkansas), accounted for the most injuries (65 minor, 45 serious) and all the fatalities (11). Two of the fatalities were evacuation-related: one passenger died from smoke inhalation in the rear of the airplane; a second passenger died 16 days after the accident as a result of thermal injuries suffered while evacuating from an overwing exit. The type of injuries that occurred in this accident included smoke inhalation, burns, and fractures.

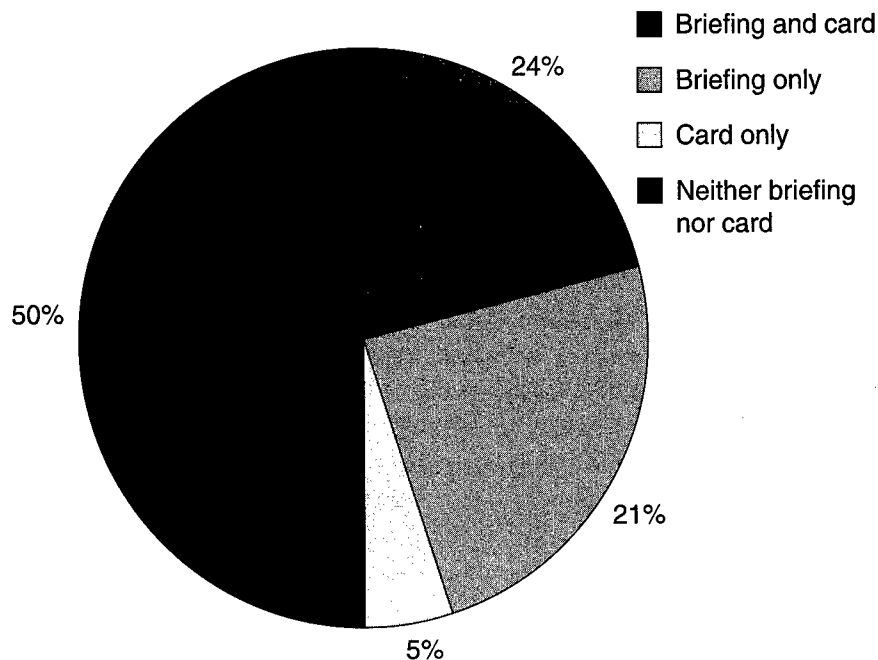
Some of the air carriers make a point to individually brief passengers on the exit row tasks. In the six study cases for which the Safety Board received overwing exit operation information, 9 of the 42 exit row passengers reported receiving such a briefing (figure 5–7). Four of these passengers reported examining their safety card. Twenty-four passengers reported receiving no briefing, and only two of these passengers had examined their briefing card. The two briefed passengers who opened overwing exits reported no difficulties. Four passengers who did not receive a briefing opened overwing exits. Two of these passengers reported no difficulty with the exit whereas the other two reported difficulties with their exit.

Figure 5-7. Percentage of exit row passengers who indicated whether or not they paid attention to safety information.

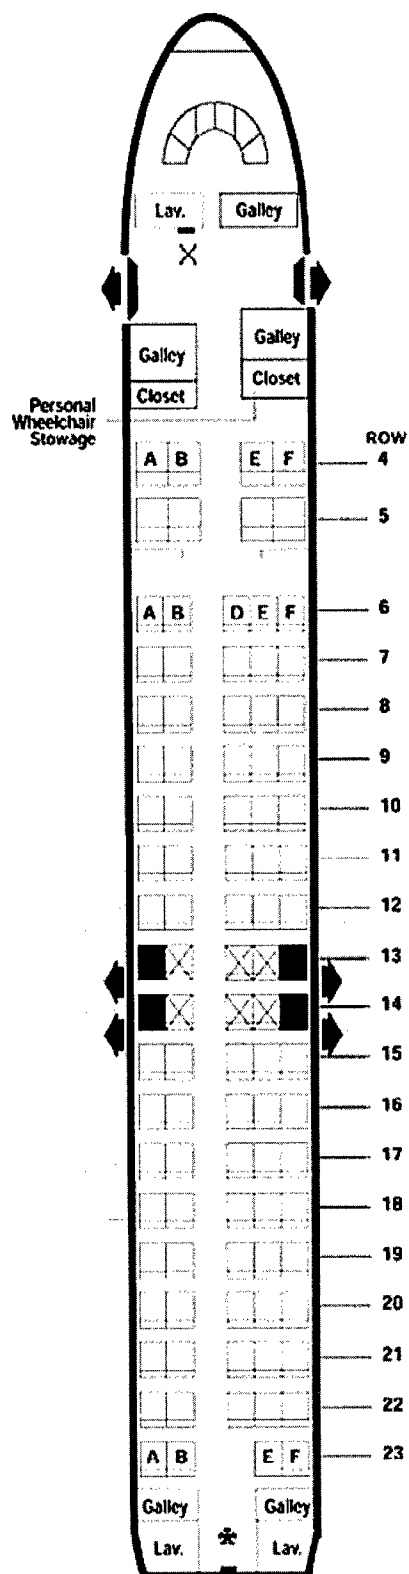
The exit configuration of some Fokker airplanes is unique among jet airplanes in that it does not have any exits in the rear of the airplane. On the Fokker 100 (F100), the forward flight attendant is responsible for the L1 and R1 floor level exits, which are adjacent to the jumpseat where the flight attendant is seated. The aft flight attendant is responsible for opening the forward overwing exits 10 rows and 47 passengers forward of the rear jumpseat where the flight attendant is seated (figure 5–8).⁶² A flight attendant involved in the evacuation of an F100 in Charlotte, North Carolina (case 41) indicated that passenger evacuation in this case would have been helped had there been an emergency exit in the rear of the aircraft. The F100 on which the flight attendant was working was equipped with floor level exits in the forward part of the cabin and four overwing exits. The aft flight attendant's assigned primary exit was a forward overwing exit. The two right overwing exits were blocked by a fire on the right main gear. Passengers from the middle and rear of the airplane were evacuating from the two left overwing exits. The passengers at these exits operated their exits prior to the flight attendant reaching the overwing area.

Figure 5-8. The Fokker 100 exit configuration. The aft flight attendant position is marked by the *. The forward flight attendant position is marked by the X.

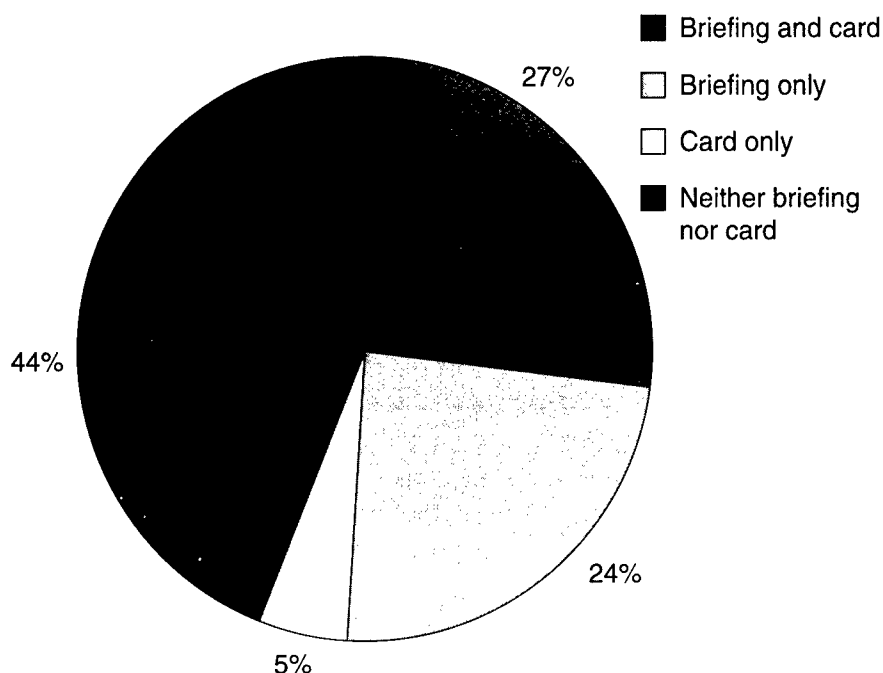
Passenger use of the safety cards on the airplanes in the study cases was consistent with previous findings that passengers tend not to look at the cards.⁷⁹ Of the 431 passengers who reported about reading the safety card, 68 percent (293) indicated that they did not read the safety card. Of those, 89 percent (259) indicated that they had read the card on previous flights. Of particular concern is that 44 percent (175) of 399 responding passengers reported that they neither examined the safety card nor listened to the safety briefing (figure 7-1).

Figure 7-1. Percentage of all passengers who indicated whether or not they paid attention to safety information.
